SAN FRANCISCO
PORT OF EMBARKATION
HISTORIC STRUCTURE REPORT

Golden Gate National Recreation Area
National Park Service

ARCHITECTURAL RESOURCES GROUP

February 1991

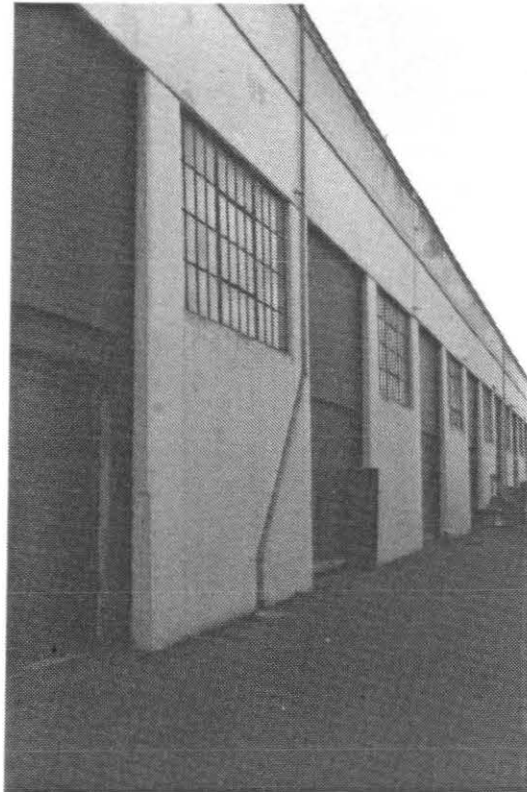
Exterior battered concrete wall on Pier Shed 3.

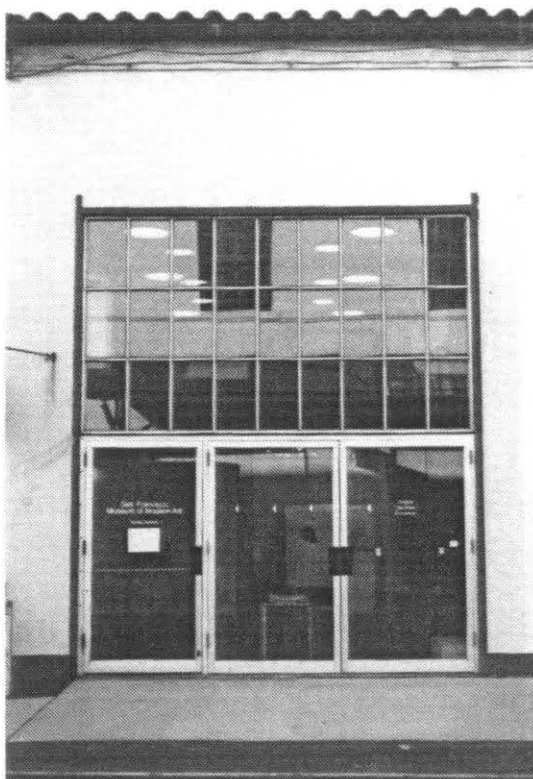
Storefront installed in the opening of a large door in Building A.

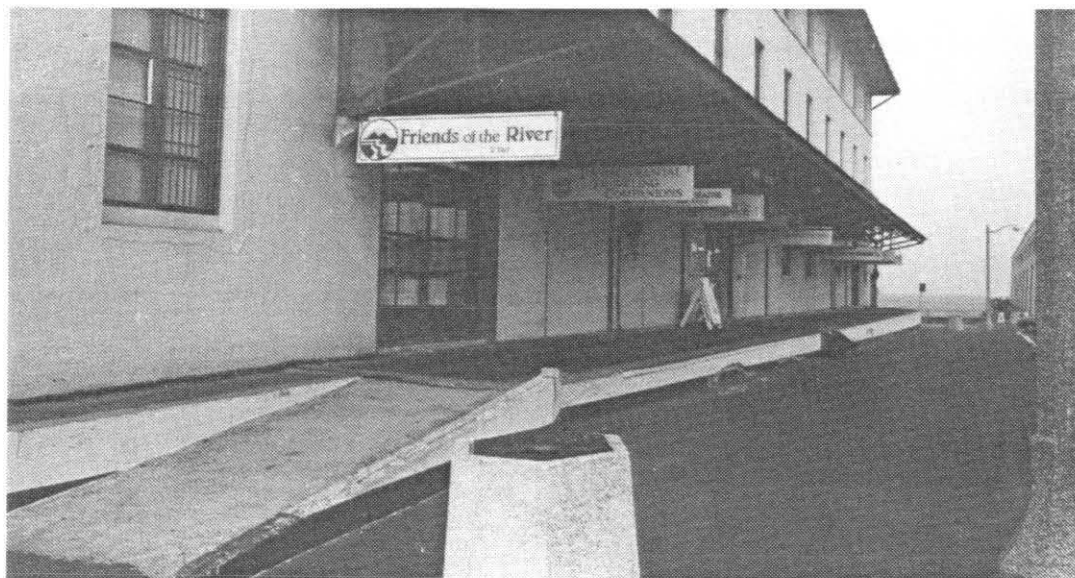
Settling on a loading dock caused by the 1989 earthquake.

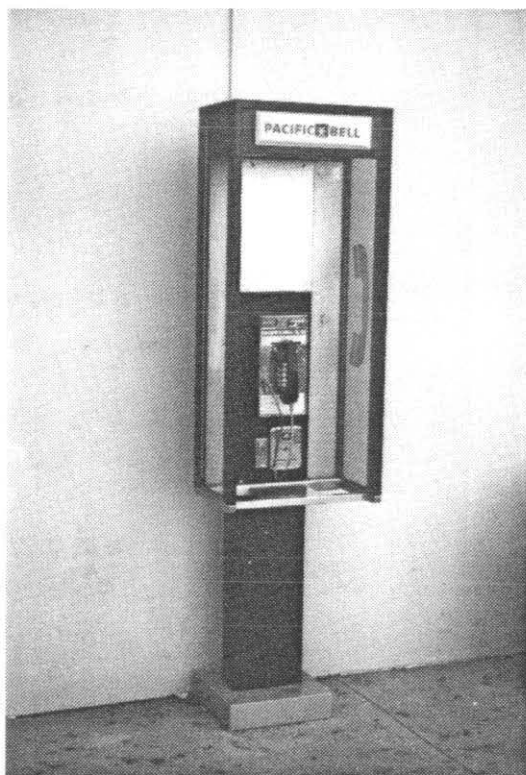
*left -- Public telephone
and trash container of
an inappropriate type.*

Trash Containers. Containers typically used in parks or public spaces are inappropriate as they detract from the character of the site. It is recommended that containers with an industrial character be used throughout the site.

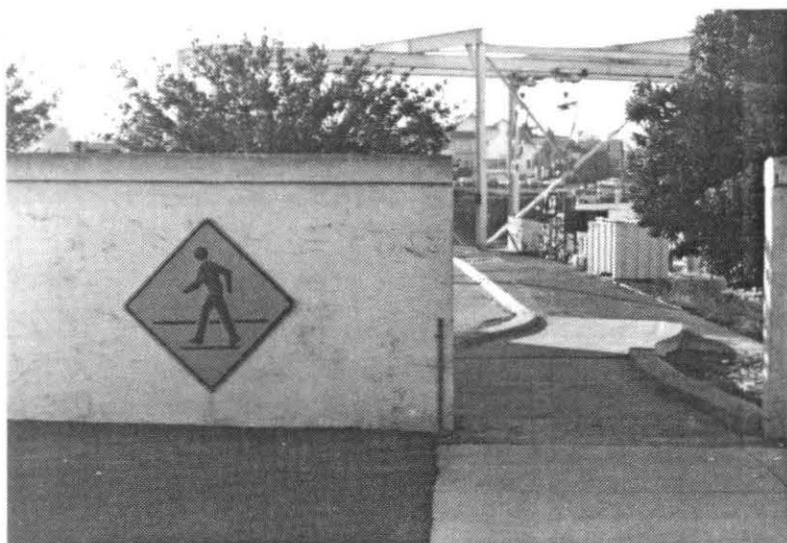
above -- A sign that is too large. In many situations smaller signs should be considered.

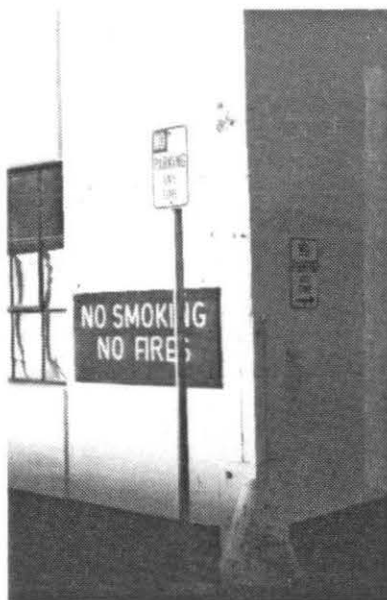
right -- Sign clutter is an unsightly problem ameliorated by an organized sign system, part of an overall site plan.
